Inspection Report

Sample Commercial

Property Address:
123 Entrepreneur Avenue
Charlotte NC

King Construction, Inc dba Inspector Paul

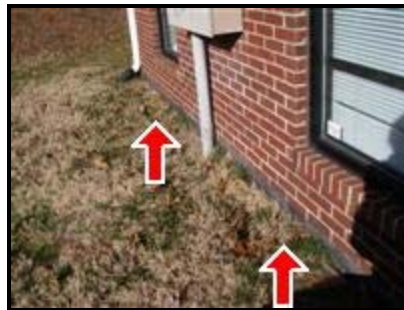
1.0 Picture 1

1.0 A bituminous coating was applied to the rear of the building near the right corner, evidence suggests this was done post construction to address a water intrusion issue. With out recent rains and personal past experience with the building we can not be sure if the corrective measures are successful. Recommend obtaining written documentation and disclosure from the owners including receipts, warranties, etc. or further evaluation and repair as needed by a qualified licensed general contractor.

A bituminous coating was applied to the rear of the building near the right corner, evidence suggests this was done post construction to address a water intrusion issue. With out recent rains and personal past experience with the building we can not be sure if the corrective measures are successful. Recommend obtaining written documentation and disclosure from the owners including receipts, warranties, etc. or further evaluation and repair as needed by a qualified licensed general contractor.

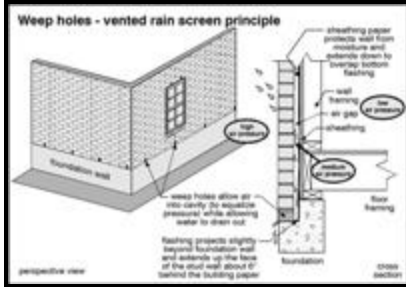
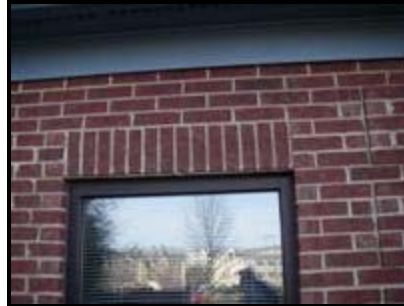
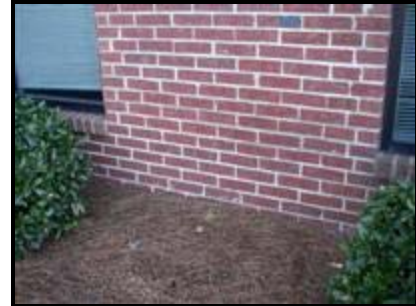
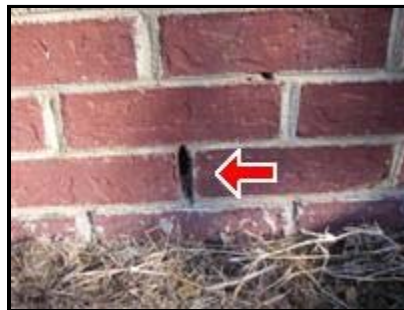
2.0 (1) Other than at the foundation line on the rear of the building, no weep holes were located in the first course of masonry above the flashing (foundation line and the lintels). These are typically spaced not more than 48 inches on center and not less than 3/16 inch in diameter. Opinions on installing post construction weep holes varies widely. It is not possible to verify proper through wall flashing with out being destructive. Recommend further evaluation and repair as needed by a qualified licensed general contractor.

(1) Other than at the foundation line on the rear of the building, no weep holes were located in the first course of masonry above the flashing (foundation line and the lintels). These are typically spaced not more than 48 inches on center and not less than 3/16 inch in diameter. Opinions on installing post construction weep holes varies widely. It is not possible to verify proper through wall flashing with out being destructive. Recommend further evaluation and repair as needed by a qualified licensed general contractor.

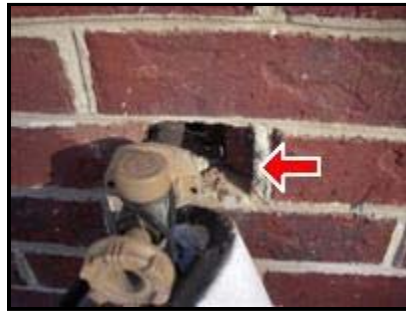
2.0 Picture 5

(2) Large hole in the veneer around the rear hose bib should be professionally sealed to reduce water and pest intrusion. Recommend further evaluation and repair as needed by a qualified licensed general contractor.

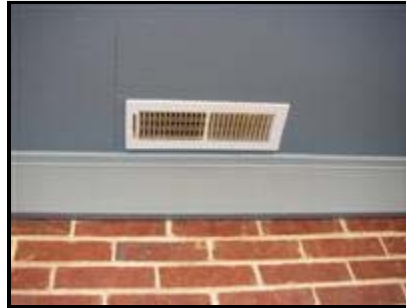
2.4 Picture 1

2.4 (1) HVAC diffuser in the exterior front porch ceiling is not connected to anything (FYI).

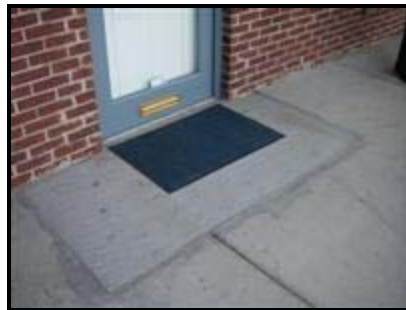
2.4 Picture 2

(2) Concrete patio near the entrance door to unit 200 was repaired/worked on at some point (FYI).

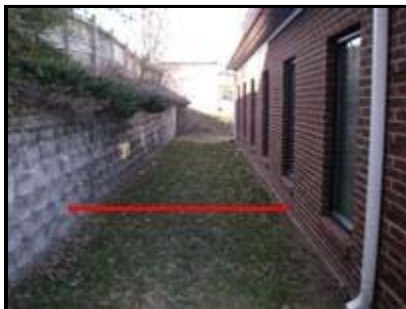
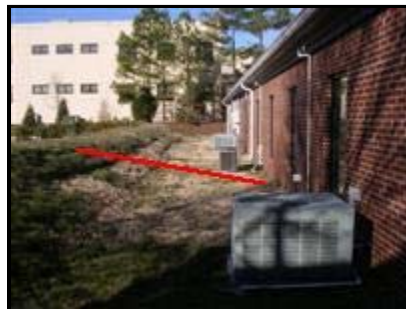
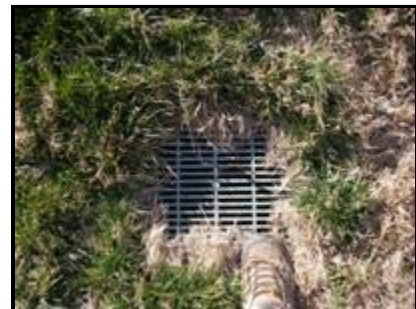
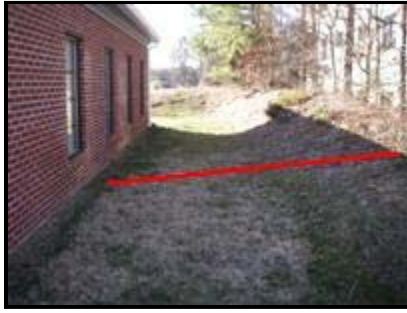
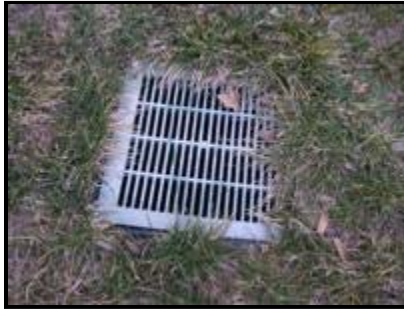
2.5 Negative slope towards left side (facing front), right side, and rear. The slope in this area is not likely to drain water away from the building and no swale or alternative measures other than some catch basins in the rear and right yard were visible. Repairs are advised to keep water away from the foundation. Recommend further evaluation and repair as needed by a qualified licensed general contractor.

Negative slope towards left side (facing front), right side, and rear. The slope in this area is not likely to drain water away from the building and no swale or alternative measures other than some catch basins in the rear and right yard were visible. Repairs are advised to keep water away from the foundation. Recommend further evaluation and repair as needed by a qualified licensed general contractor.

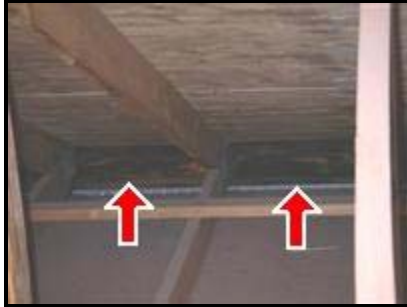
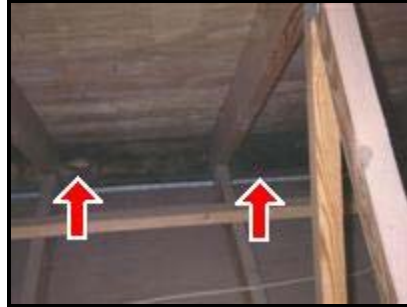
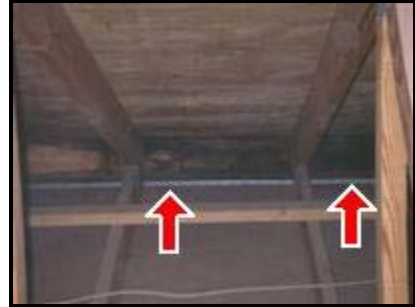
2.6 The eave visible from the attic has deterioration on the front of the building at the porch area and unit 100. Further deterioration is likely unless the water intrusion issues are corrected. Recommend further evaluation and repair as needed by a qualified licensed general contractor.

The eave visible from the attic has deterioration on the front of the building at the porch area and unit 100. Further deterioration is likely unless the water intrusion issues are corrected. Recommend further evaluation and repair as needed by a qualified licensed general contractor.

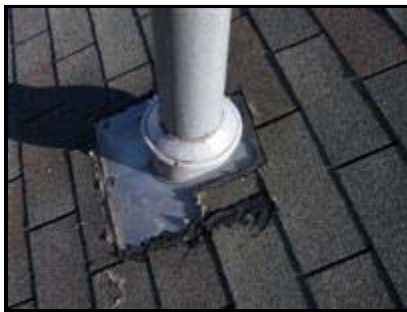
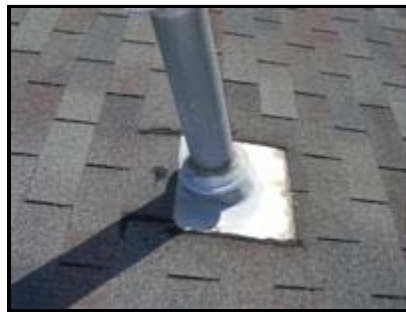
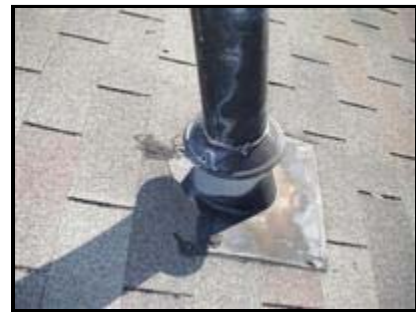
3.0 Roof shingles have been sealed with an elastomeric roof type sealant around the penetrations. These types of repairs should not be considered permanent or workmanlike. Recommend further evaluation and repair as needed by a qualified licensed roofing contractor.

Roof shingles have been sealed with a elastomeric roof type sealant around the penetrations. These types of repairs should not be considered permanent or workmanlike. Recommend further evaluation and repair as needed by a qualified licensed roofing contractor.

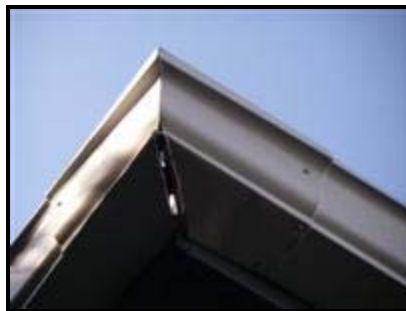
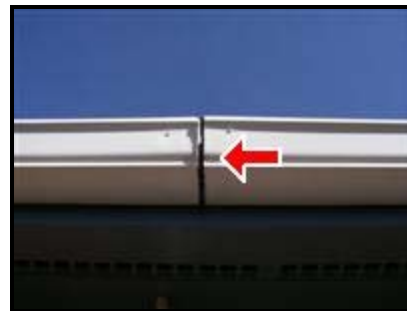
3.3 Gutter(s) leaks at seams around the building. Gutters that drain poorly or clogged can lead to many costly problems such as deterioration of fascia, soffit or roof edge. It can also cause gutters to pull loose and lead to possible water intrusion. Recommend a qualified licensed general contractor inspect and repair as needed.

Gutter(s) leaks at seams around the building. Gutters that drain poorly or clogged can lead to many costly problems such as deterioration of fascia, soffit or roof edge. It can also cause gutters to pull loose and lead to possible water intrusion. Recommend a qualified licensed general contractor inspect and repair as needed.

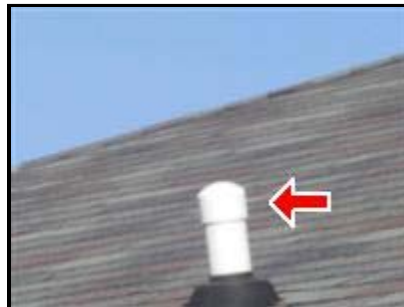
4.0 Picture 1

4.0 (1) Plumbing vent pipe nearest the right side of the building is capped, this can block/prevent proper venting and the exhaust of sewer gasses. Recommend further evaluation and repair as needed by a qualified licensed plumbing contractor.

(1) Plumbing vent pipe nearest the right side of the building is capped, this can block/prevent proper venting and the exhaust of sewer gasses. Recommend further evaluation and repair as needed by a qualified licensed plumbing contractor.

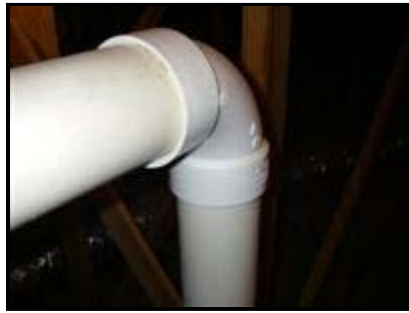
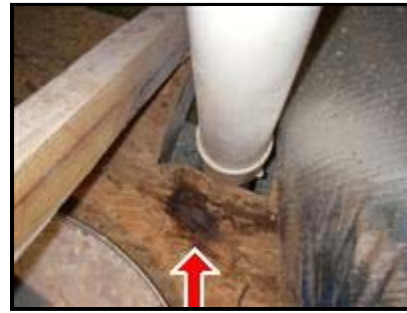
(3) Seams of the plumbing vent pipes in the attic above unit 300 were not glued together, the pipes can leak and/or separate if not corrected. Evidence of leaks under the non glued seams was present. Recommend further evaluation and repair as needed by a qualified licensed plumbing contractor.

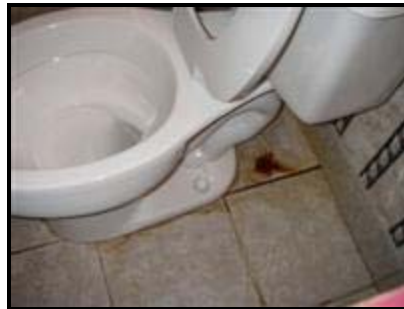
4.0 Picture 4

(4) Toilet leaks at floor at unit 100. Repairs are needed to prevent the toilet from continued leaking, a new wax seal and/or flange may be needed. Recommend a qualified licensed plumber repair or correct as needed.

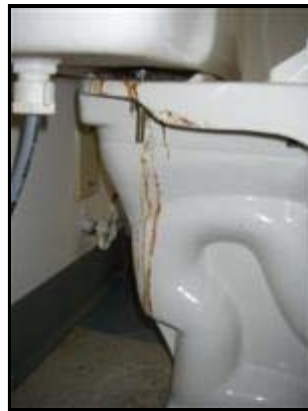
4.0 Picture 5

(5) Toilet leaks at tank mount at unit A men's and women's bath. Repairs are advised. Recommend a qualified licensed plumber repair or correct as needed.

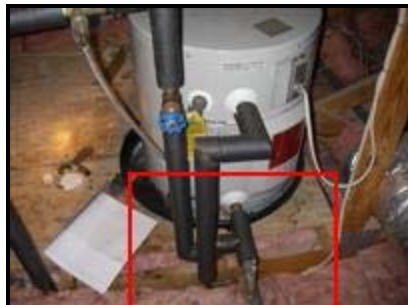
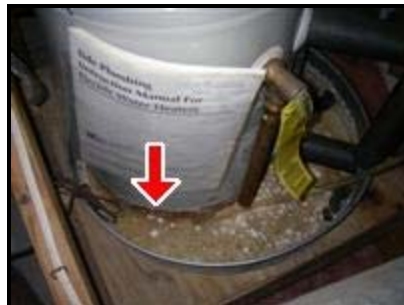
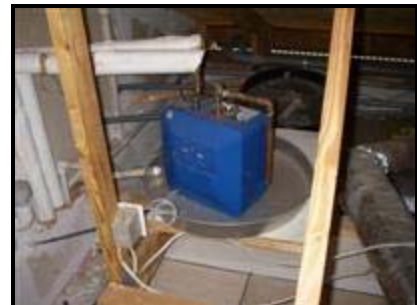
4.2 (1) Water heaters above unit 200, unit 100, and unit A do not have standard working access/space. The base of the water heater is rusted over unit 100. Recommend further evaluation and repair as needed by a qualified licensed general contractor and plumbing contractor.

(1) Water heaters above unit 200, unit 100, and unit A do not have standard working access/space. The base of the water heater is rusted over unit 100. Recommend further evaluation and repair as needed by a qualified licensed general contractor and plumbing contractor.

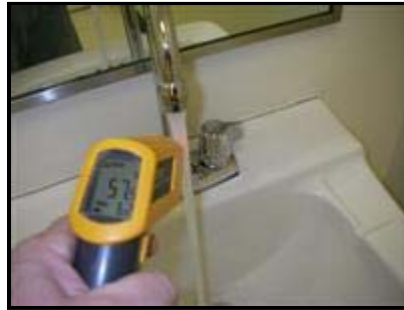
4.2 Picture 4

(2) There was no hot water in unit's B and A. Recommend further evaluation and repair as needed by a qualified licensed plumbing contractor.

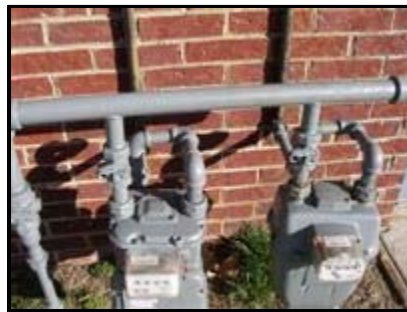
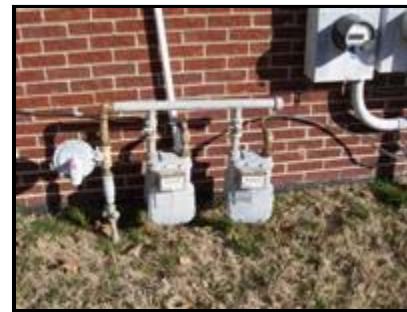
4.4 Gas was turned off at the 3 meters nearest the left side of the building, we will not be able to inspect the fuel storage and distribution systems or any gas components including furnaces in these units. Recommend a qualified professional from the gas company inspect when they turn the gas back on.

Gas was turned off at the 3 meters nearest the left side of the building, we will not be able to inspect the fuel storage and distribution systems or any gas components including furnaces in these units. Recommend a qualified professional from the gas company inspect when they turn the gas back on.

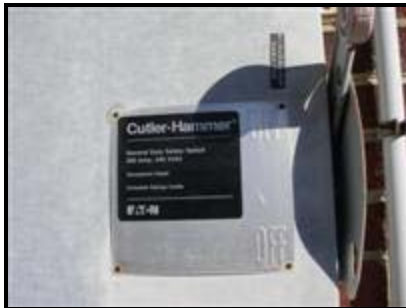
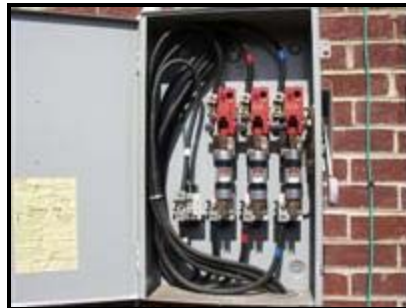
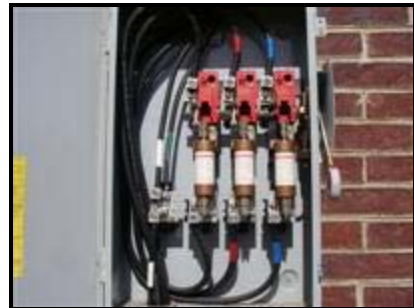
5.1 Power had to be turned off at the service disconnects to open the cover. We did not open the two center service disconnects, we did not want to turn off power to the current tenant. No visible issues were found, you may wish to have these two disconnects evaluated prior to closing at a time when it will not affect the tenant.

Power had to be turned off at the service disconnects to open the cover. We did not open the two center service disconnects, we did not want to turn off power to the current tenant. No visible issues were found, you may wish to have these two disconnects evaluated prior to closing at a time when it will not affect the tenant.

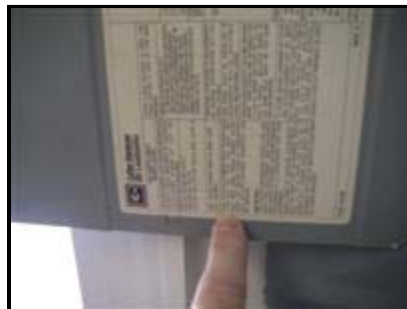
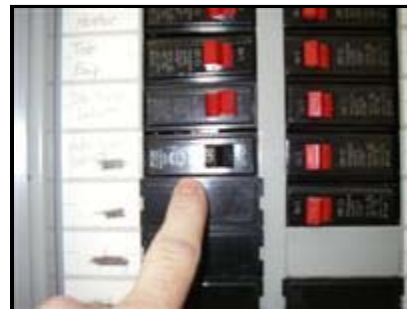
5.2 One circuit breaker in unit A panel is of a different brand than panel manufacturer. The manufacturer requires that in order for the panel to be safe, only Cutler-Hammer or Westinghouse brands are allowed to be used inside the panel. Even though these circuit breakers are all "UL approved," they are not approved to be used in panels of different manufacturers unless so indicated on the panel label. Recommend further evaluation and repair as needed by a qualified licensed electrical contractor.

One circuit breaker in unit A panel is of a different brand than panel manufacturer. The manufacturer requires that in order for the panel to be safe, only Cutler-Hammer or Westinghouse brands are allowed to be used inside the panel. Even though these circuit breakers are all "UL approved," they are not approved to be used in panels of different manufacturers unless so indicated on the panel label. Recommend further evaluation and repair as needed by a qualified licensed electrical contractor.

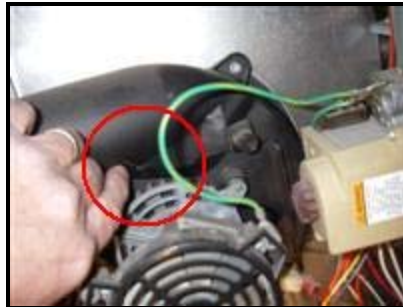
6.0 Picture 1

6.0 (1) Exhaust blower inside the furnace for unit 200 has a crack in the housing. Repairs are advised to prevent the loss of combustion gasses. Recommend further evaluation and repair as needed by a qualified licensed HVAC contractor.

(1) Exhaust blower inside the furnace for unit 200 has a crack in the housing. Repairs are advised to prevent the loss of combustion gasses. Recommend further evaluation and repair as needed by a qualified licensed HVAC contractor.

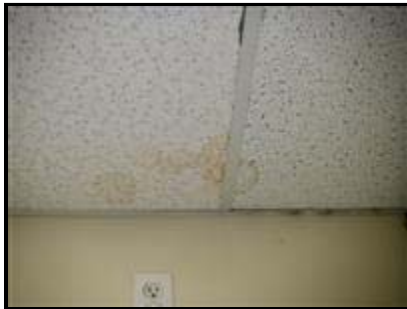
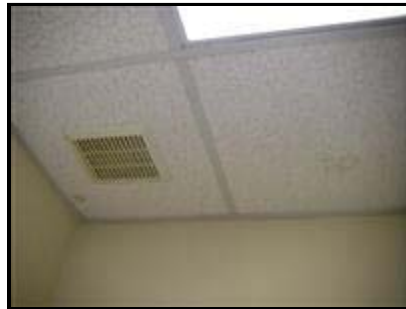
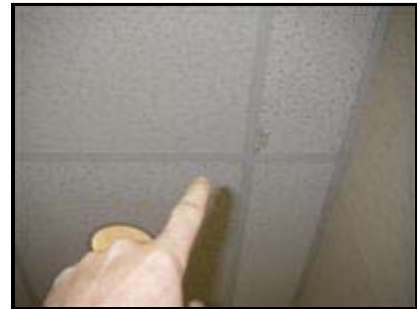
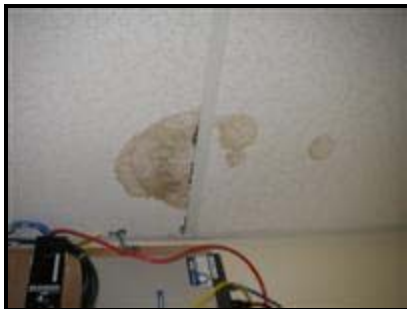
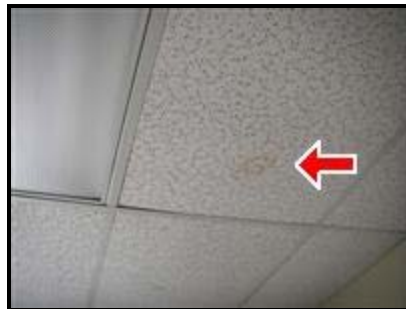
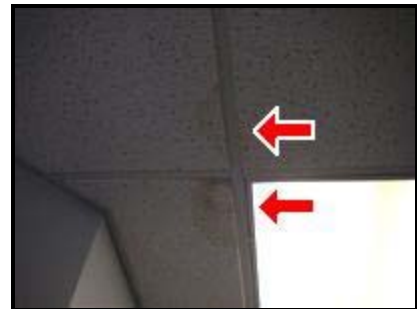
8.0 Stains were inspected on the ceilings in the bathroom of unit B, hallway in unit B, bathroom of unit 300, hallway of unit 300, rear office of unit 300, ceiling of unit 200, bathroom of unit 100. These could be the result of roof leaks, plumbing leaks, or HVAC related issues, they were all dry at the time of our inspection. Recommend further evaluation and repair as needed by a qualified licensed general contractor.

Stains were inspected on the ceilings in the bathroom of unit B, hallway in unit B, bathroom of unit 300, hallway of unit 300, rear office of unit 300, ceiling of unit 200, bathroom of unit 100. These could be the result of roof leaks, plumbing leaks, or HVAC related issues, they were all dry at the time of our inspection. Recommend further evaluation and repair as needed by a qualified licensed general contractor.

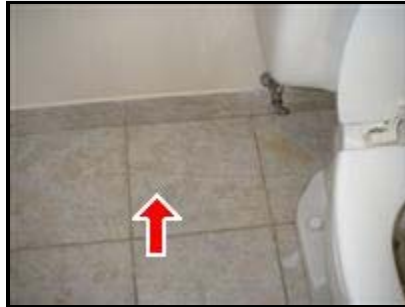
8.2 Picture 1

8.2 (1) Tile was cracked near the toilet in unit 300 bathroom. Recommend further evaluation and repair as needed by a qualified licensed general contractor.

(1) Tile was cracked near the toilet in unit 300 bathroom. Recommend further evaluation and repair as needed by a qualified licensed general contractor.

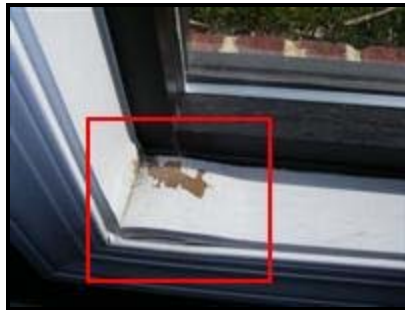
8.6 Picture 1

8.6 Evidence of leaks were inspected on the window sill on the left side in unit 100. The area was dry at the time of the inspection. Recommend further evaluation and repair as needed by a qualified licensed general contractor.

Evidence of leaks were inspected on the window sill on the left side in unit 100. The area was dry at the time of the inspection. Recommend further evaluation and repair as needed by a qualified licensed general contractor.

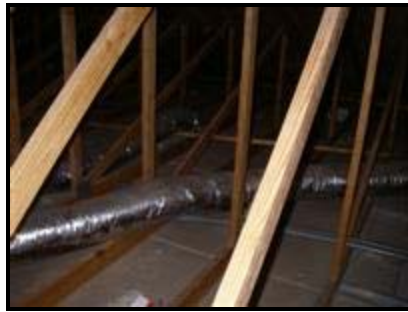
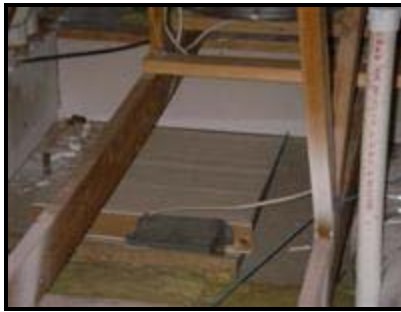
9.0 Large sections of the attic have no visible insulation. Recommend further evaluation and repair as needed by a qualified licensed general contractor.

Large sections of the attic have no visible insulation. Recommend further evaluation and repair as needed by a qualified licensed general contractor.

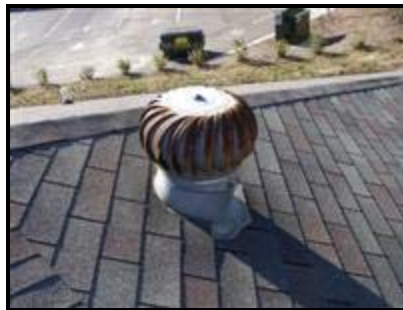
9.1 Picture 1

9.1 Turbine vent nearest the right side of the building is squeaking rather loudly. Recommend further evaluation and repair as needed by a qualified licensed general contractor.

Turbine vent nearest the right side of the building is squeaking rather loudly. Recommend further evaluation and repair as needed by a qualified licensed general contractor.

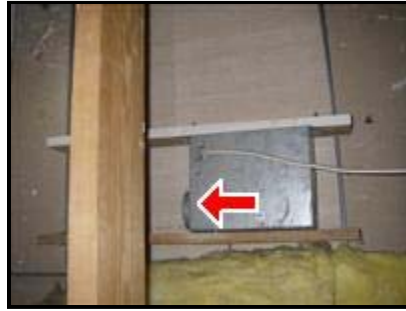
9.2 Picture 1

9.2 Bathroom exhaust fans do not vent to the outside. Vent pipes that terminate in attic space can sometimes cause moisture that can lead to mold or cause condensation. Recommend a qualified licensed general contractor inspect and repair as needed.

Bathroom exhaust fans do not vent to the outside. Vent pipes that terminate in attic space can sometimes cause moisture that can lead to mold or cause condensation. Recommend a qualified licensed general contractor inspect and repair as needed.
