Inspection Report

Sample Commercial

Property Address:
123 Entrepreneur Avenue
Charlotte NC

King Construction, Inc dba Inspector Paul

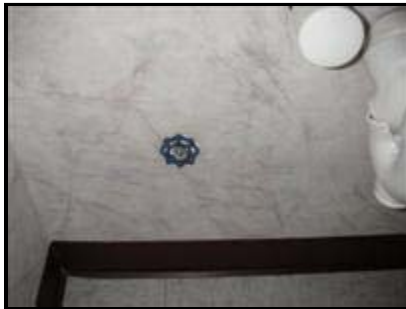
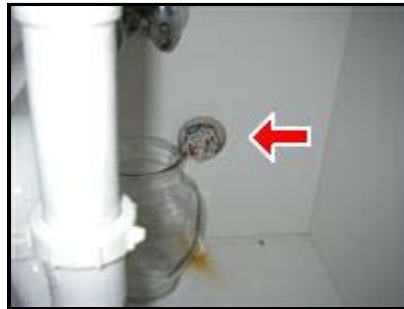
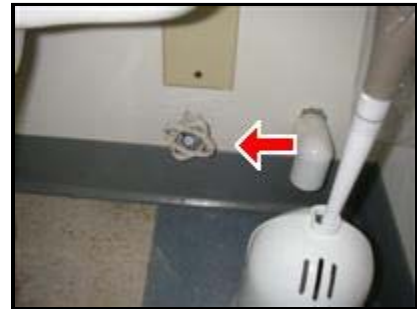
4.3 The main shut off are the blue knobs located on the wall under the sink in the bathroom in unit 200, under the hall sink base cabinet in unit 100 under the men's toilet in unit A. This is for your information.

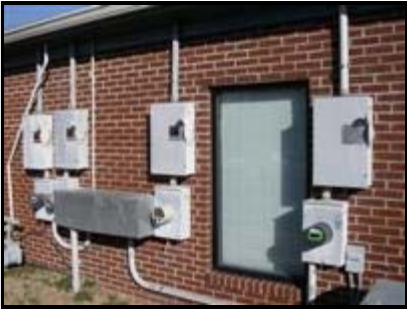
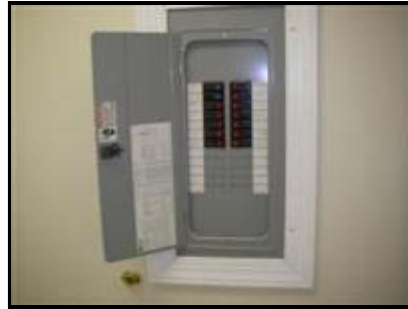
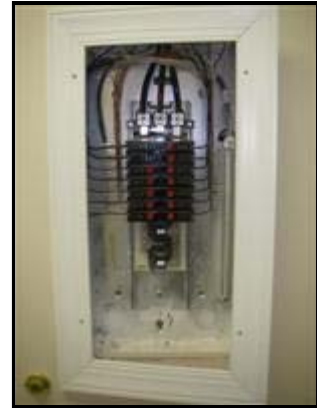
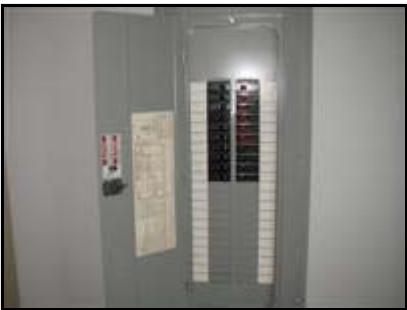
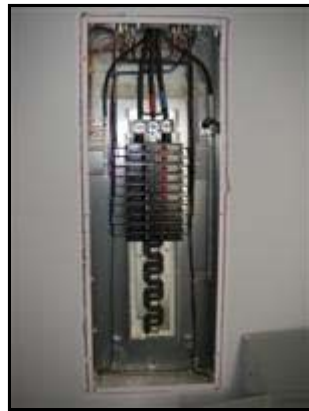
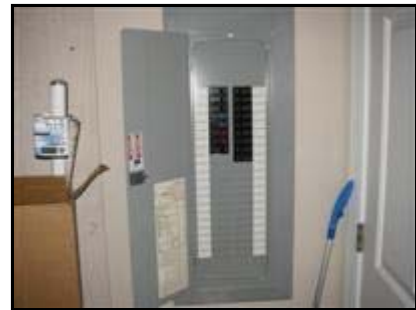
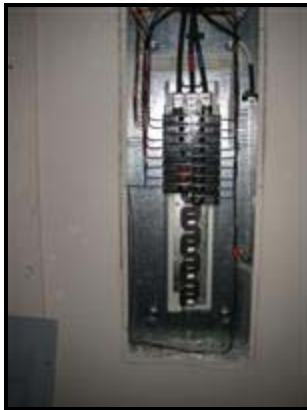
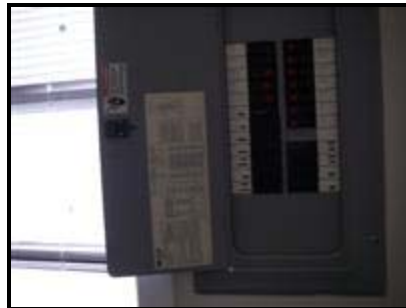
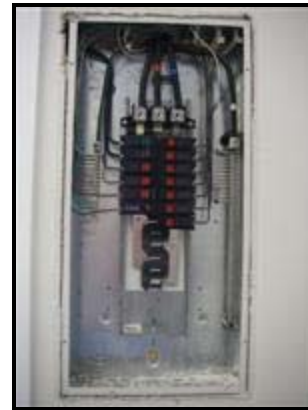
5.6 Unit sub panel boxes are located at unit B bathroom, unit 200 hallway, unit 100 hall closet, unit A rear right

corner room. However, main disconnect (shut-offs) are outside at meter base panel (for your information).
